Manhole Inspection Summary

Manhole # S47II_022MH

Insp Date: **5/2/08 10:24 AM**

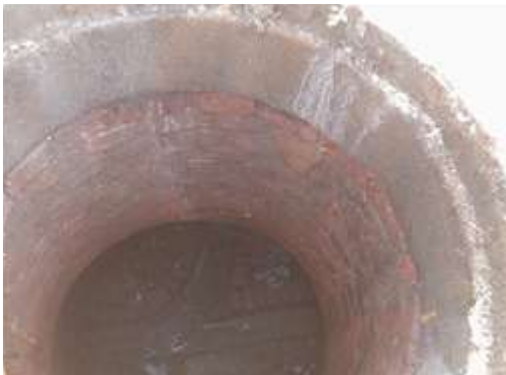
Defect 1

Frame Offset: **0** (in.) Condition: ☐ Sound ☐ Cracked ☒ **Leaks**

Frame Leaks

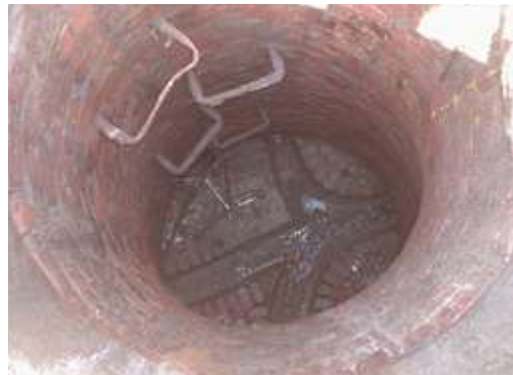
Defect 2

Condition: ☐ Sound ☐ Cracked ☐ Root Intrusion ☒ **Loose Brick** ☒ **Deteriorated**

Infiltration: ☐ None ☒ **Joint** ☐ Cracks ☐ Mortar ☐ Roots ☐ Wall

Deterioration

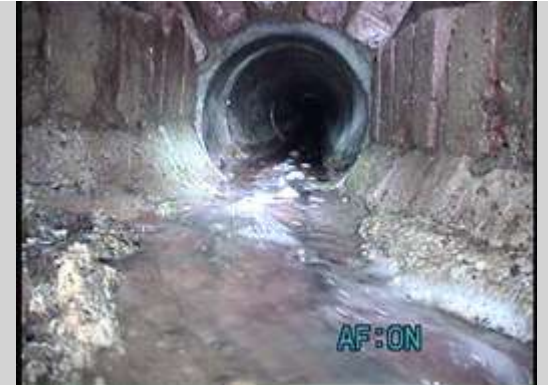
12 O'Clock Outflow

8 in. Circular Gravity Sewer
Pipe Out @ 12 O'Clock

Pipe Height: **8.4** (in.) Rod and Bar (Angled)
Pipe Material: **Clay** ☐ Pipe Lined
Invert Depth: **10.20** (ft.) Flow Characteristics: **Fast**
Deposits: ☒ None ☐ Mud ☐ Sludge ☐ Debris ☐ Grease
Silt Depth: (in.) Deposits Extent:
Infiltration: **None** Pipe Seal Cond: **Sound**

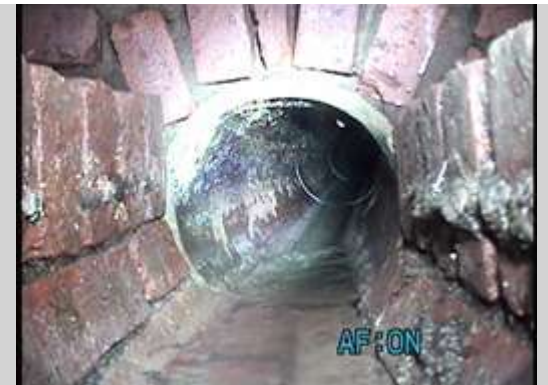
6 O'Clock Inflow

8 in. Circular Gravity Sewer
Pipe In @ 6 O'Clock

Pipe Height: **8.4** (in.) Rod and Bar (Angled)
Pipe Material: **Clay** ☐ Pipe Lined
Invert Depth: **10.10** (ft.) Flow Characteristics: **Slow**
Deposits: ☒ None ☐ Mud ☐ Sludge ☐ Debris ☐ Grease
Silt Depth: (in.) Deposits Extent:
Infiltration: **None** Pipe Seal Cond: **Sound**

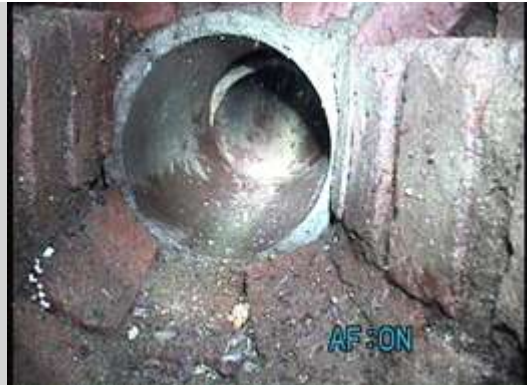
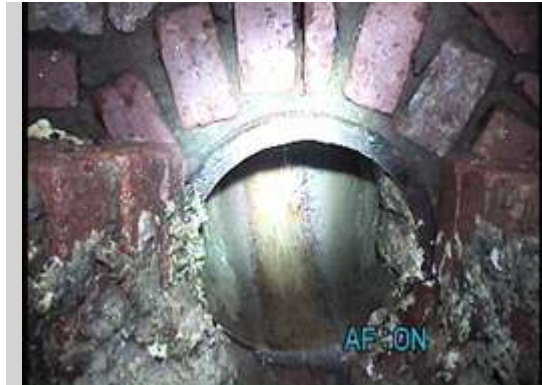
9 O'Clock Inflow

Pipe In @ 3 O'Clock

Drop In @ 3 O'Clock

Pipe Height: **8.4** (in.) Rod and Bar (Angled)

Infiltration: **None** Pipe Seal Cond: **Sound**

Drop: **Outside** Rod and Bar

Drop Condition: **Open**
